HISTORIC STRUCTURE REPORT

TUMACACORI NATIONAL MONUMENT
Arizona

by
Anthony Crosby

September 1985

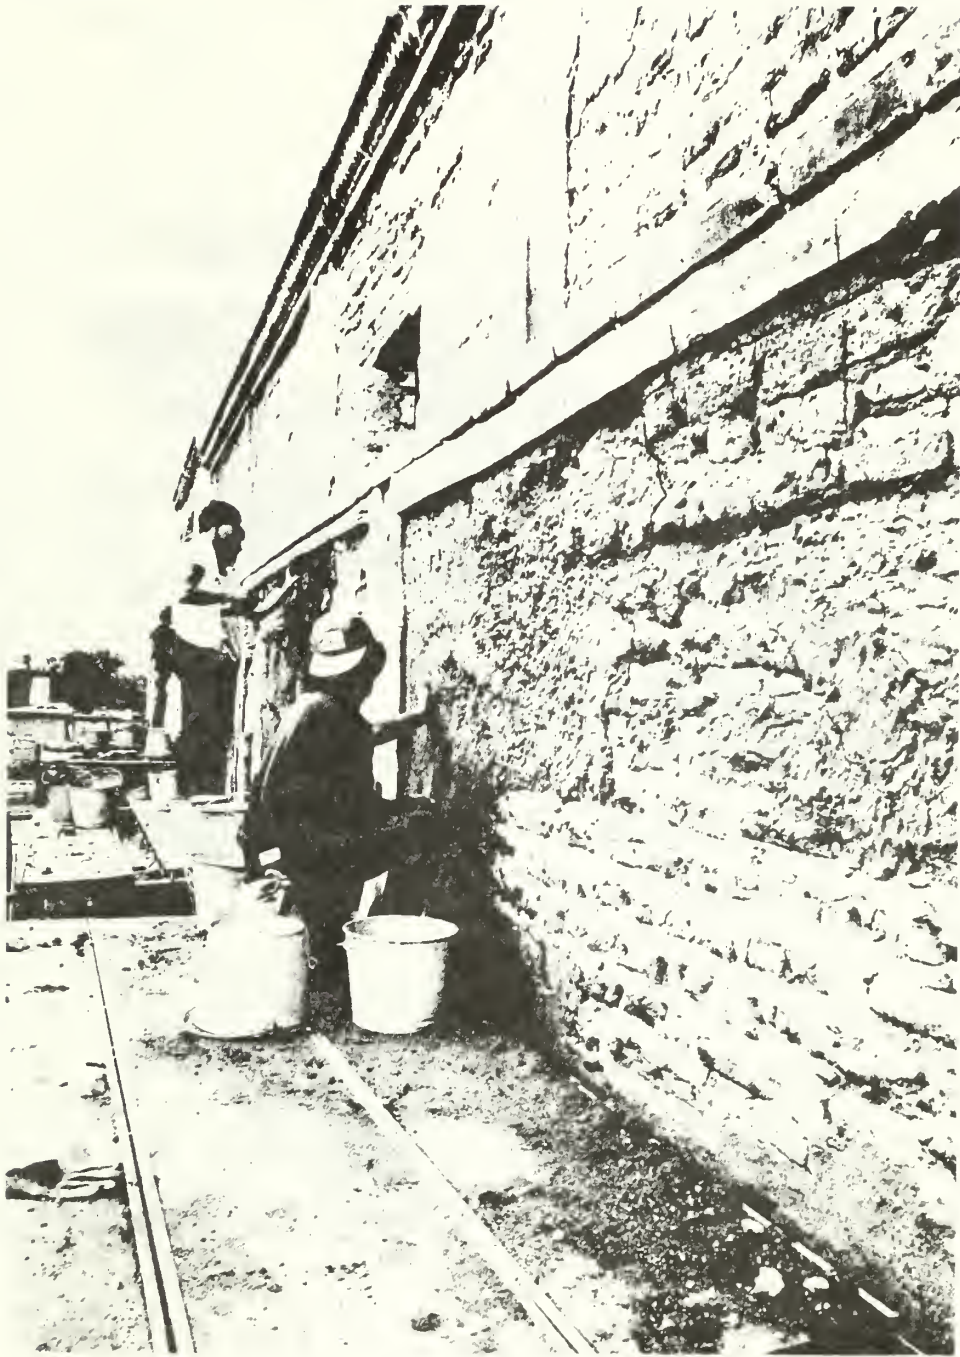
1. West church wall during the filling of voids.

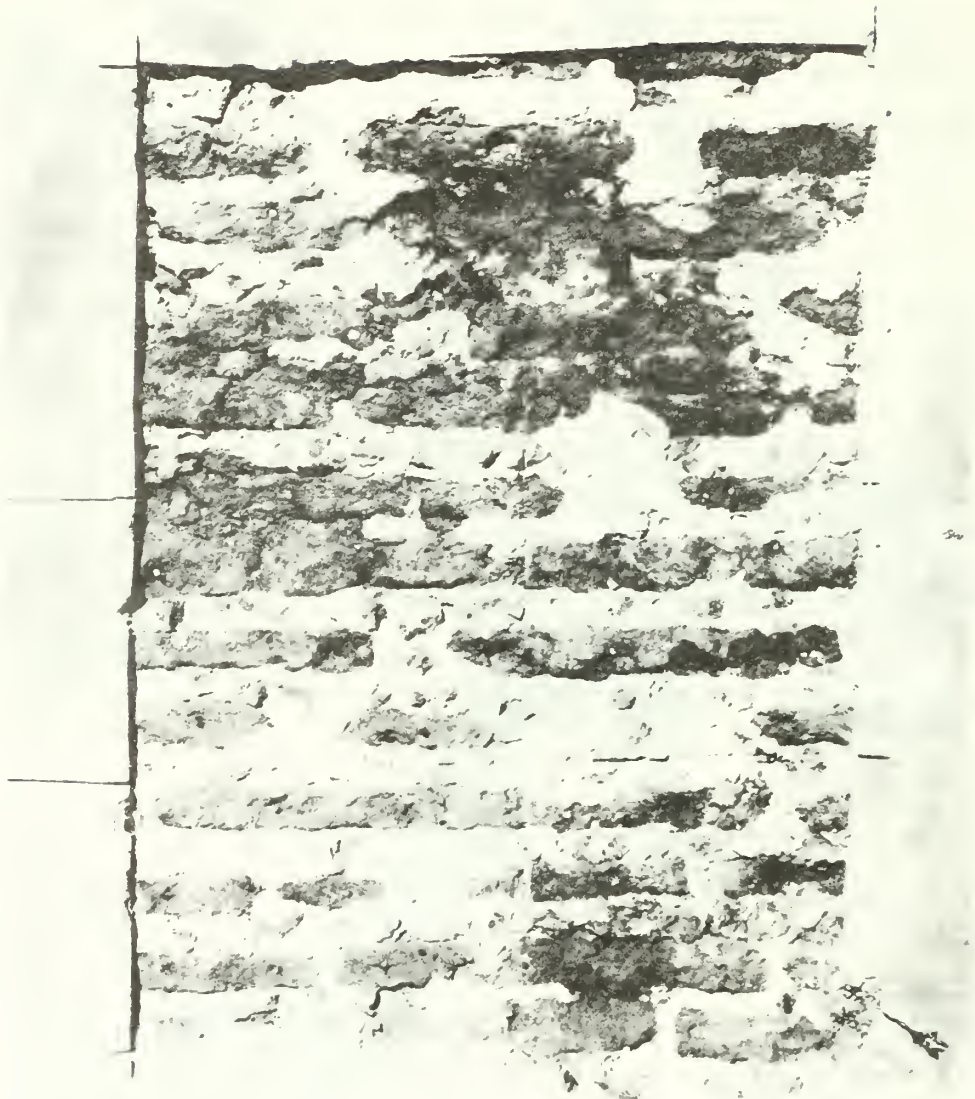
2. A view of the west exterior sanctuary wall during the removal of cement stucco.

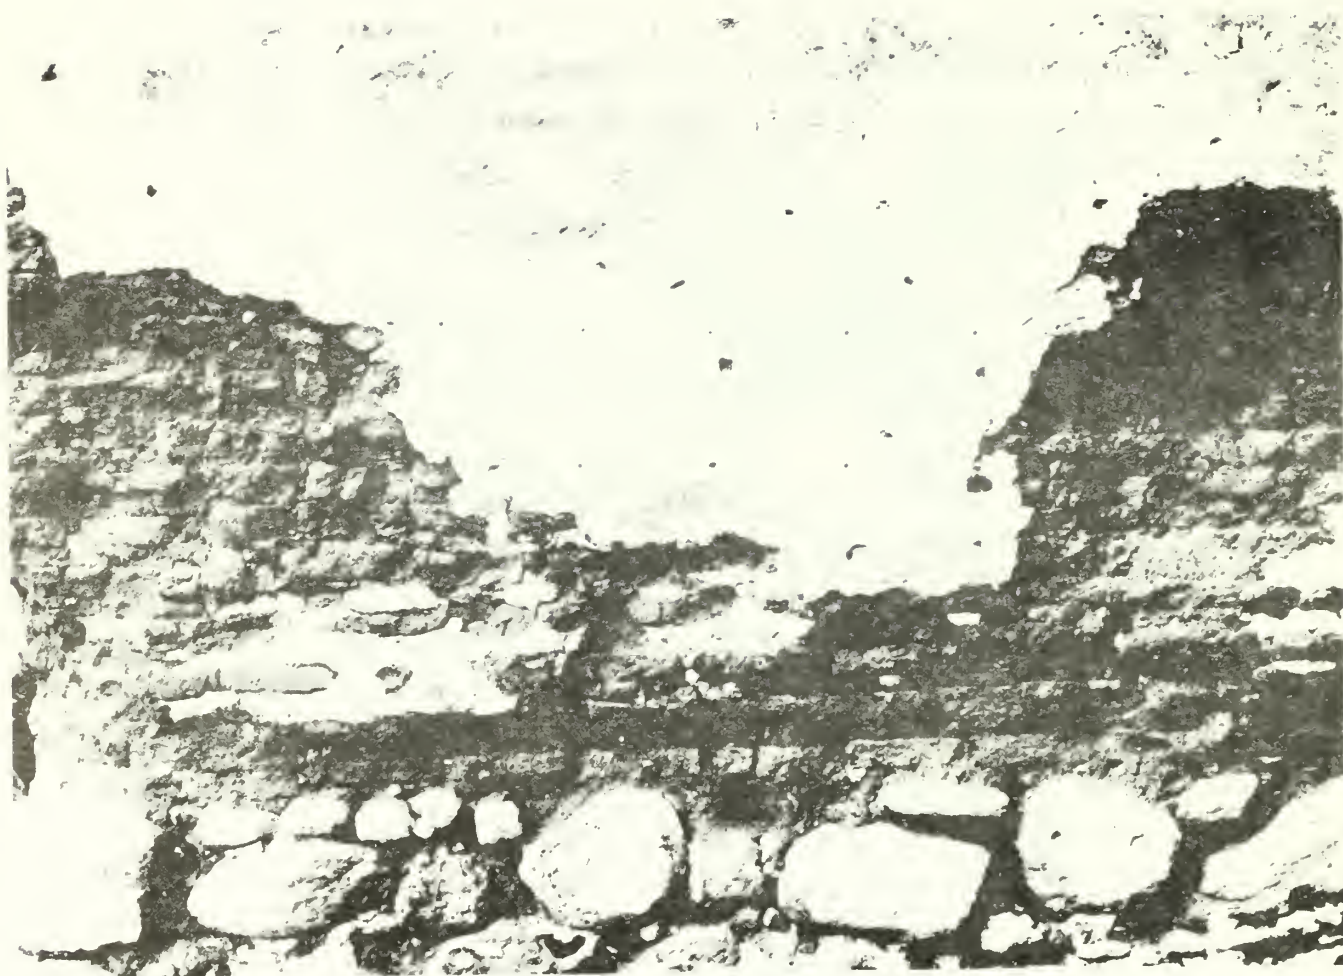
3. The north side of the bell tower after the removal of the hard cement stucco.

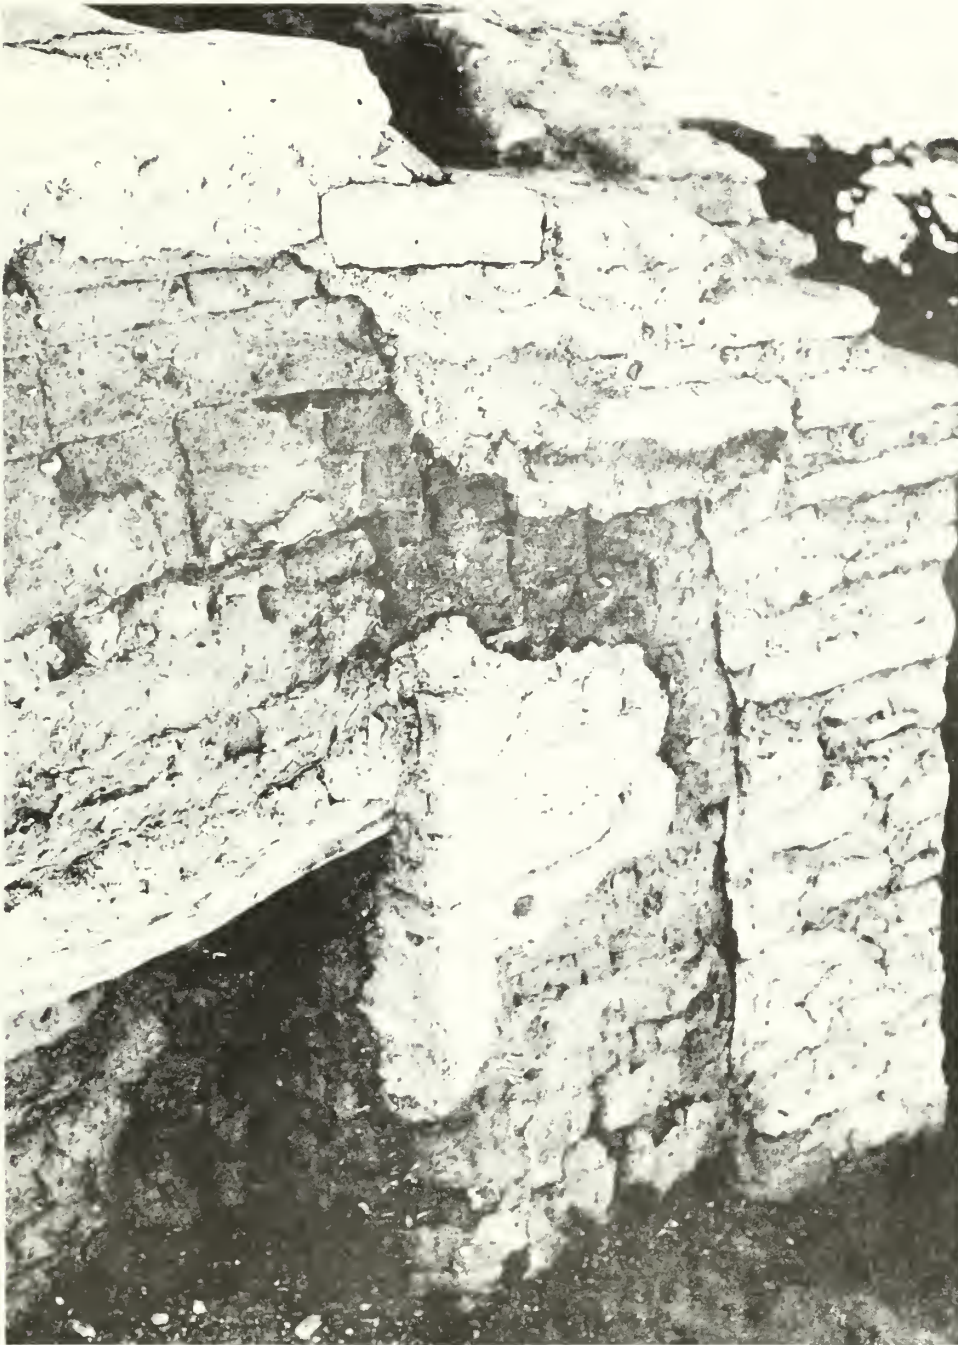
5. Northeast corner of granary showing effects of dissimilar materials.

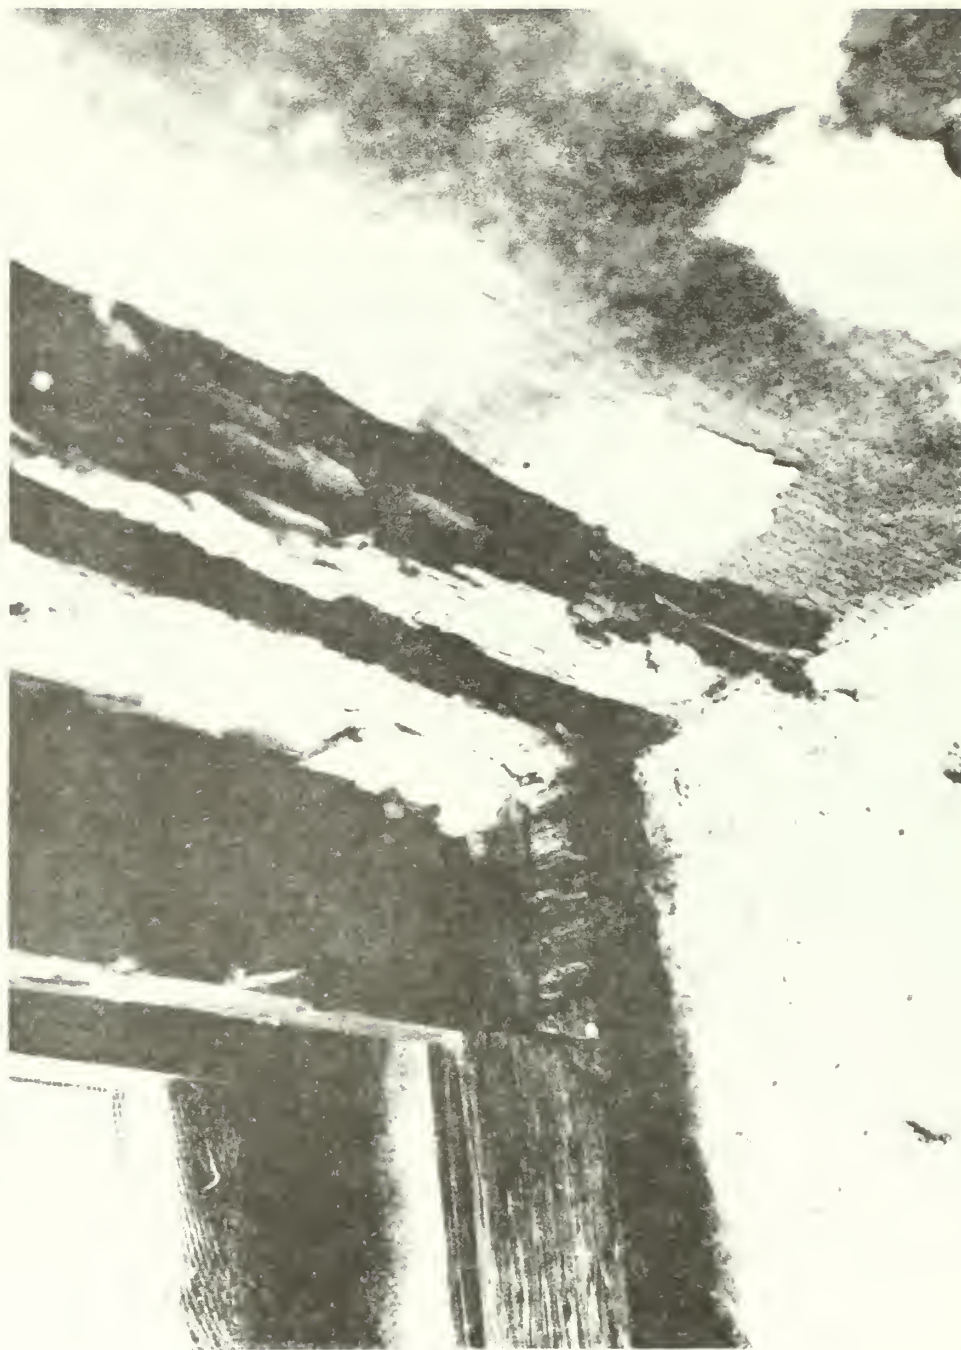
14. Deteriorated lintel in a west nave window.

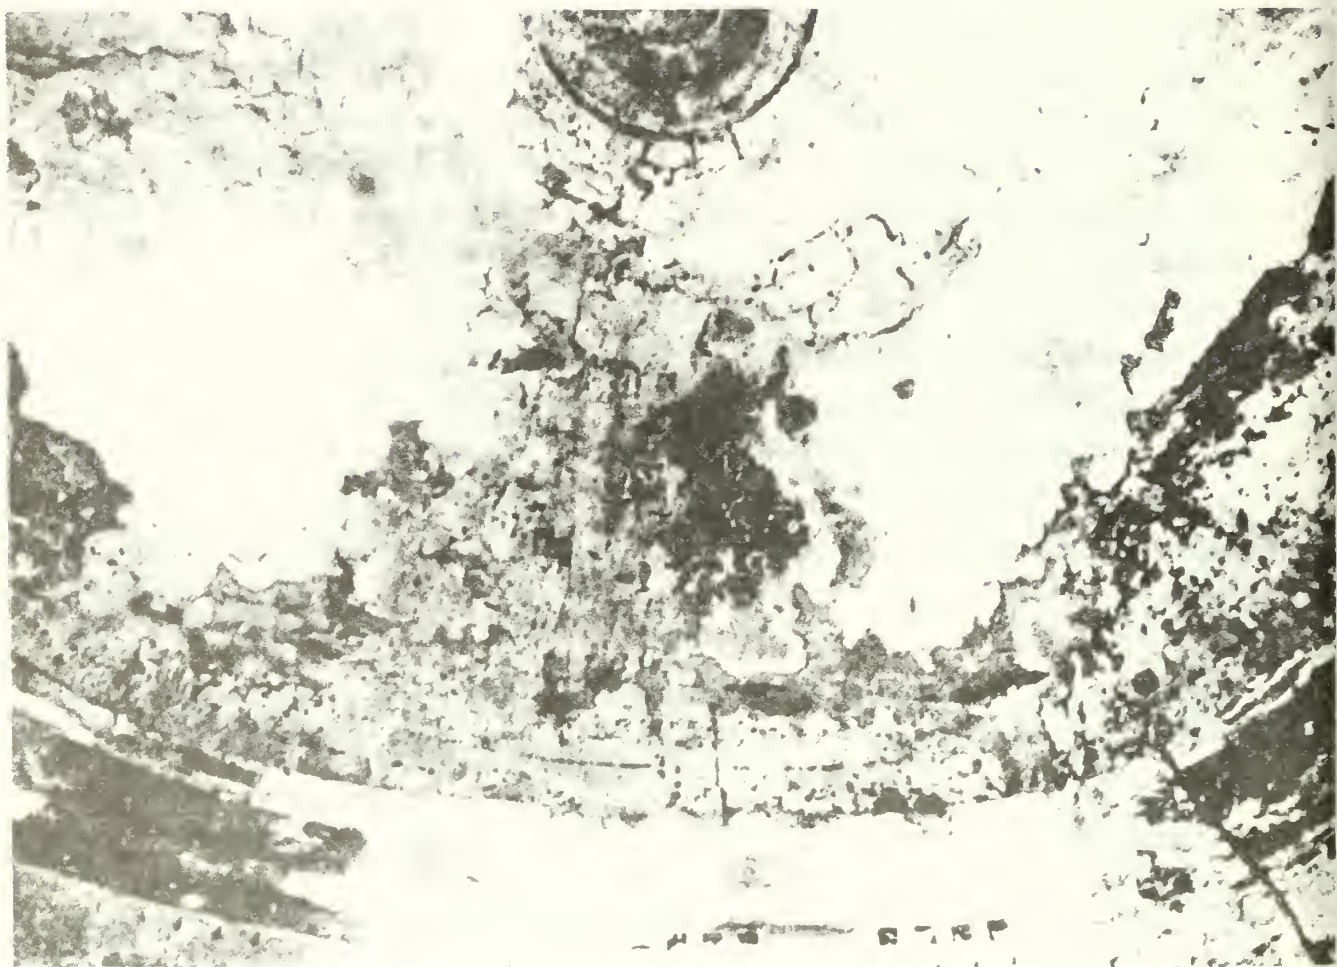
16. South side of the sanctuary dome before treatment, 1981.

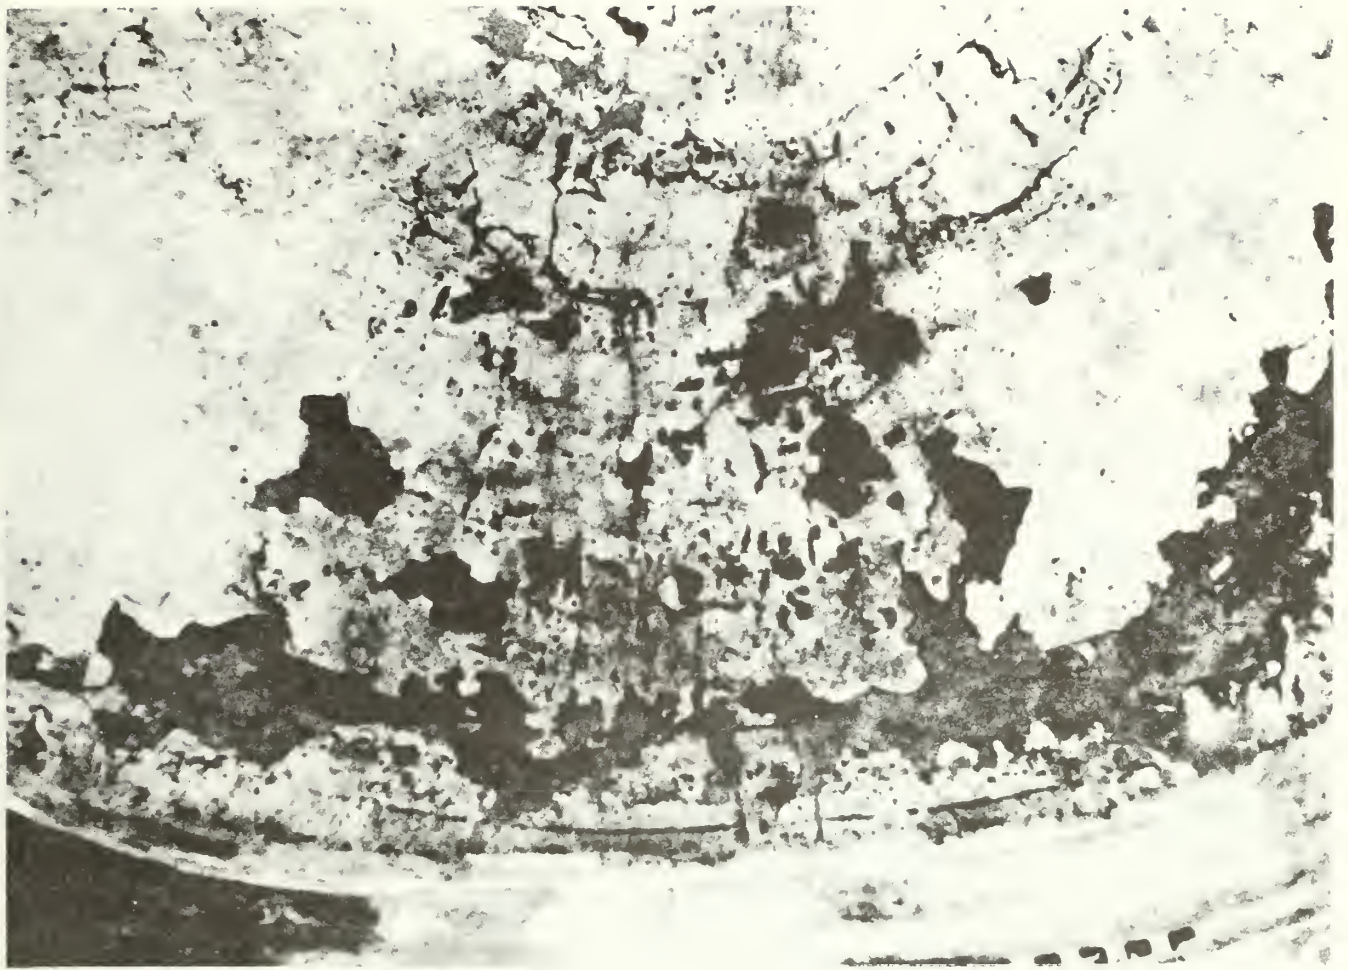
17. South side of the sanctuary dome after treatment, 1982.

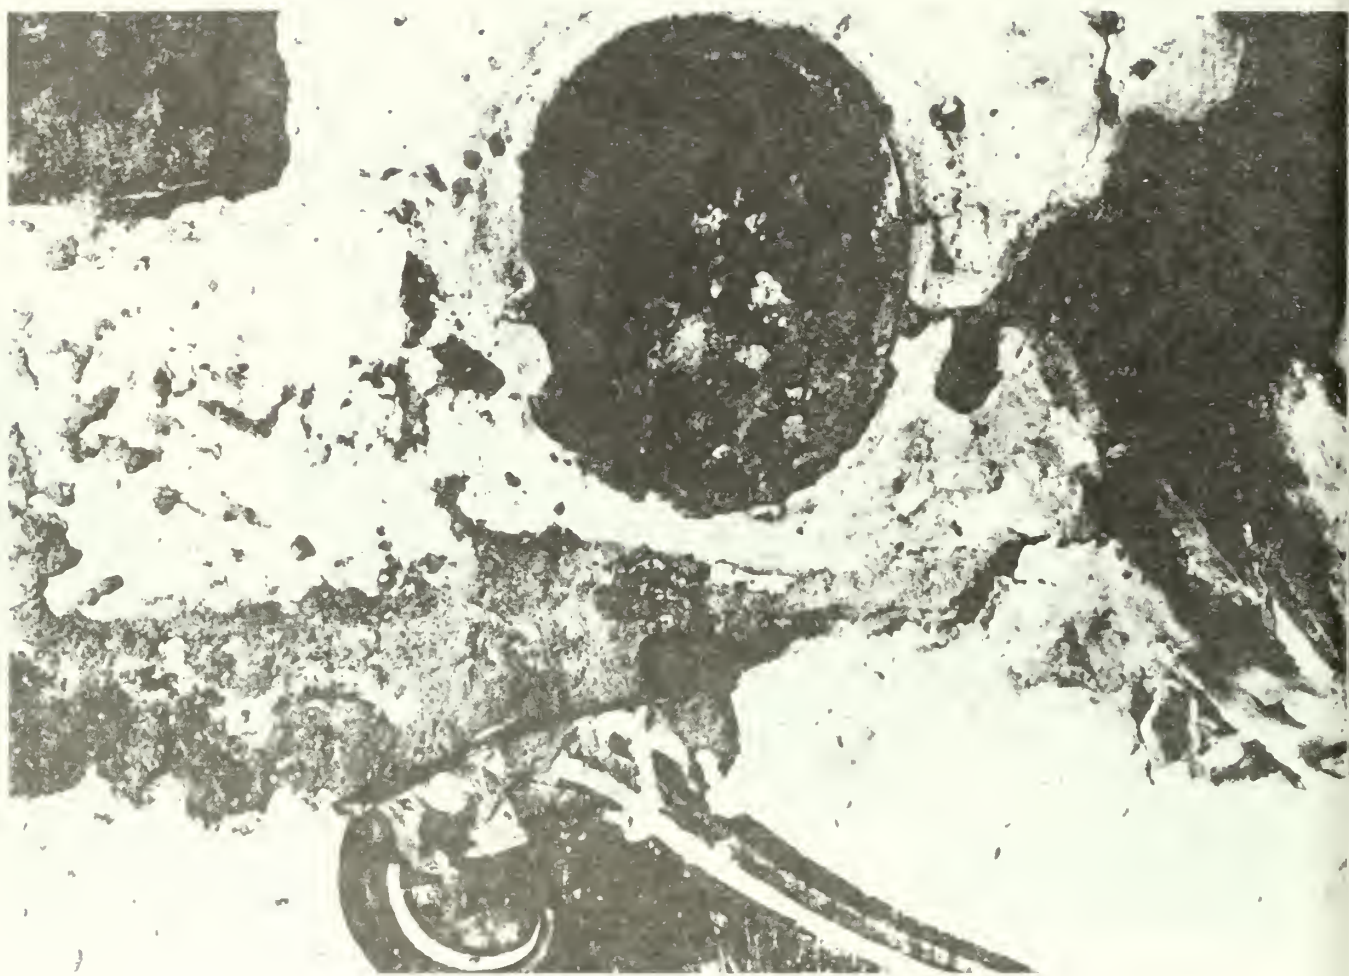
18. Painted volute on the sanctuary's north wall before treatment, June 1982.

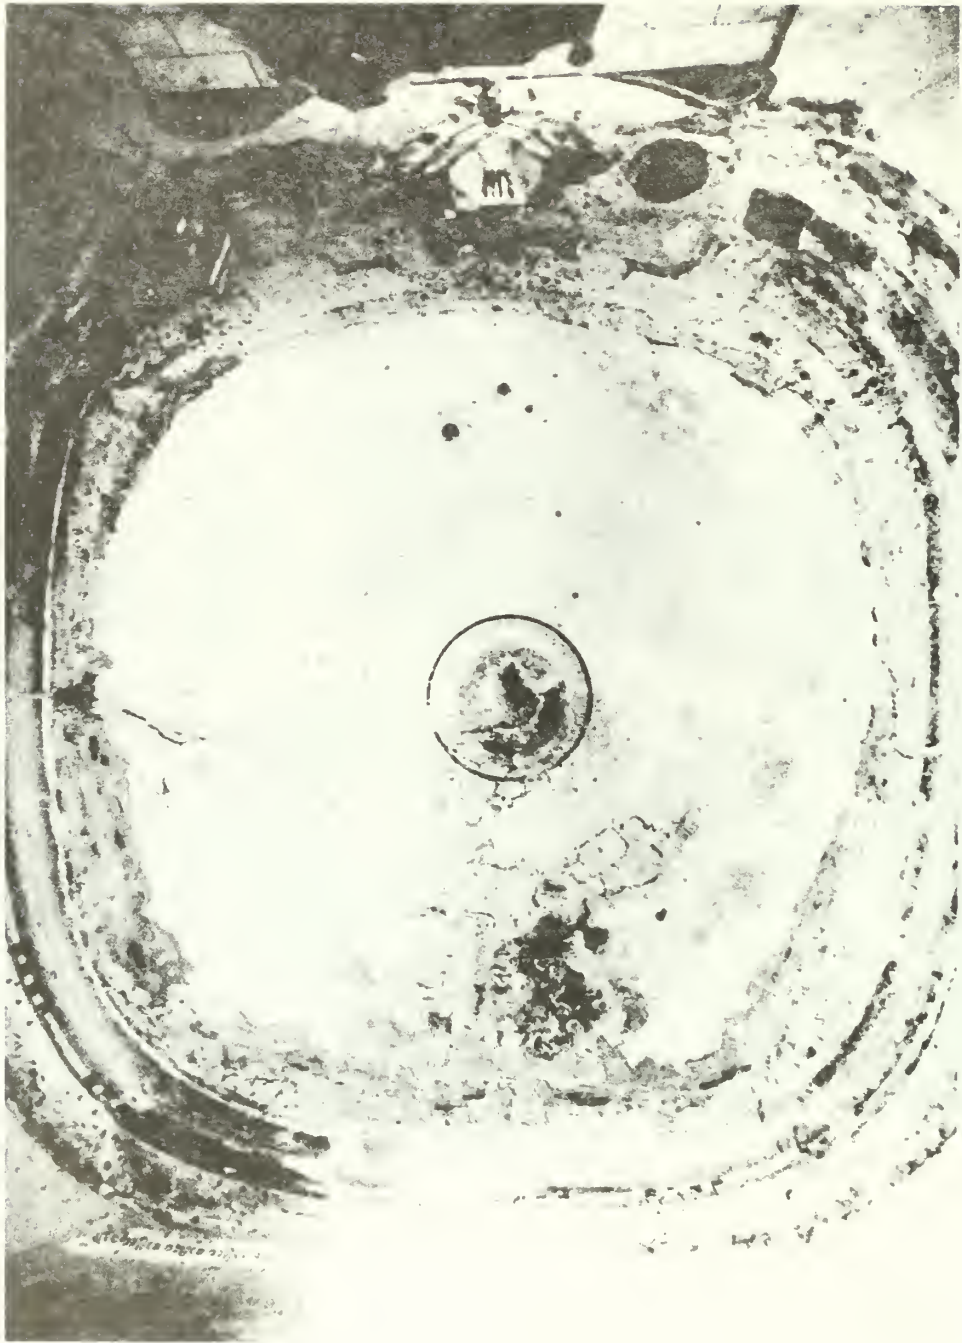
20. Interior of the dome before treatment, 1979.

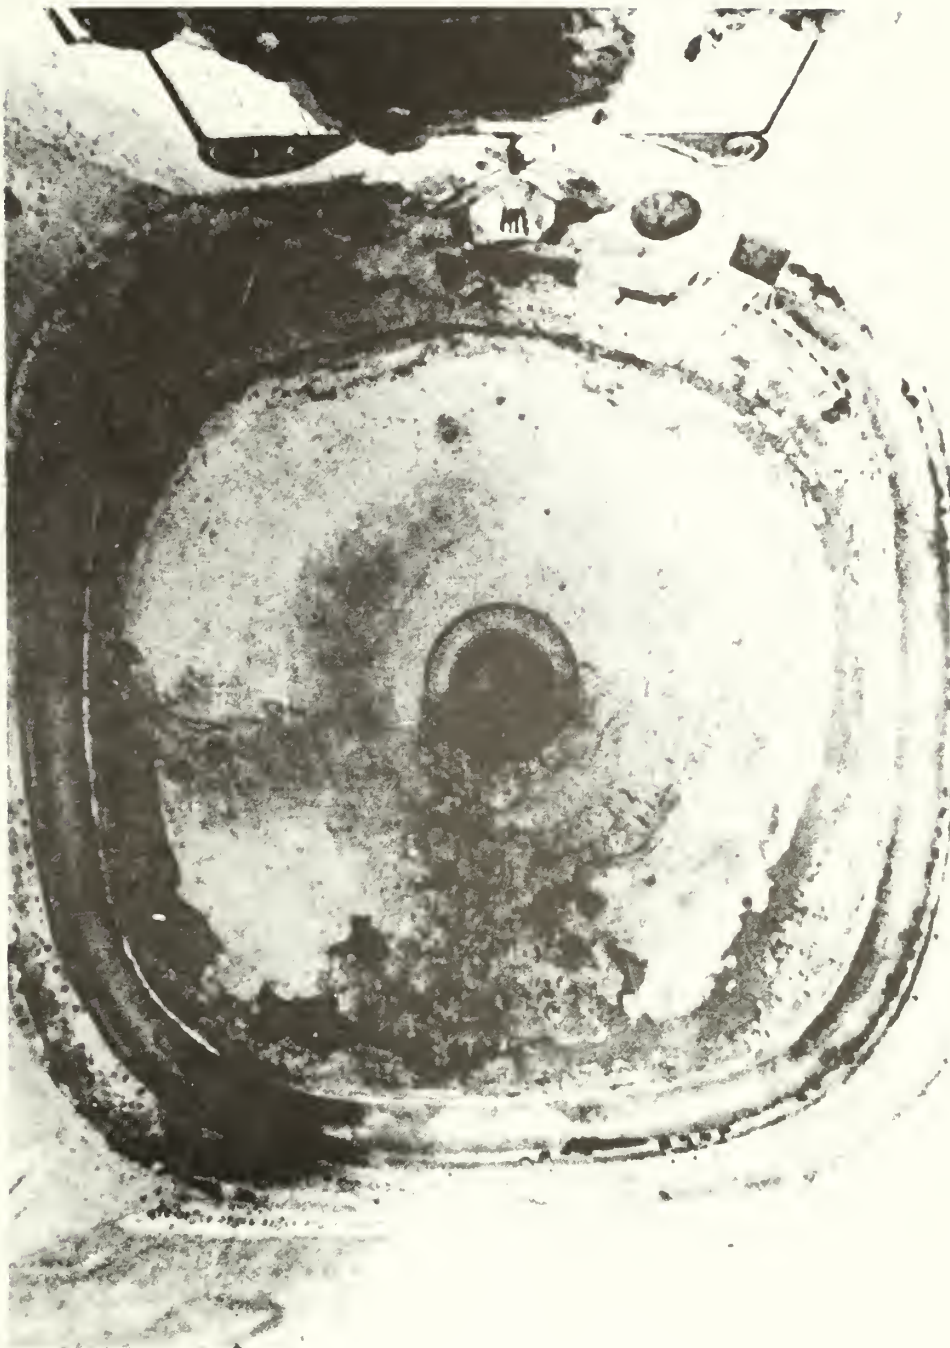
21. Interior of the dome after treatment, August 1982.

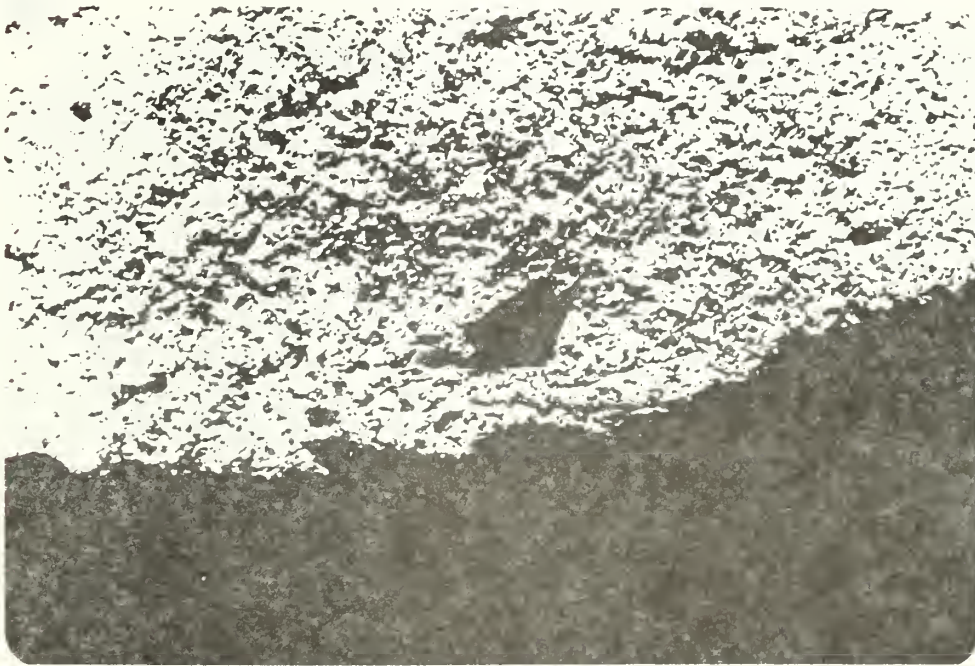
Figure 3: Detail of plaster Sample B showing edge fractures. Scale: approximately five times actual size.

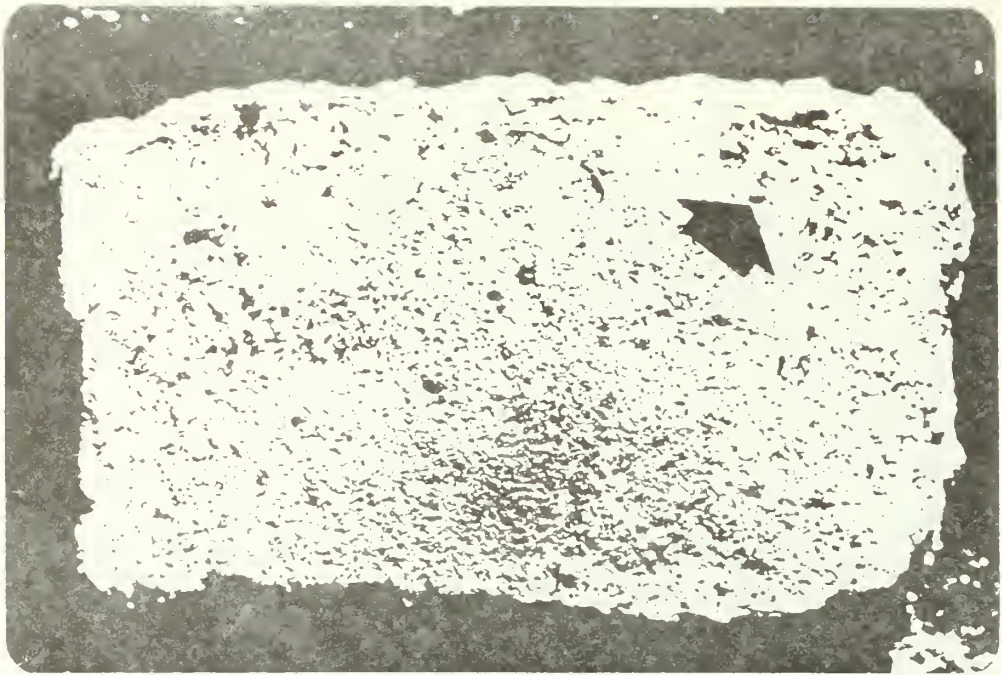
Figure 4a: Surface deterioration of plaster Sample B.
Scale: actual size.

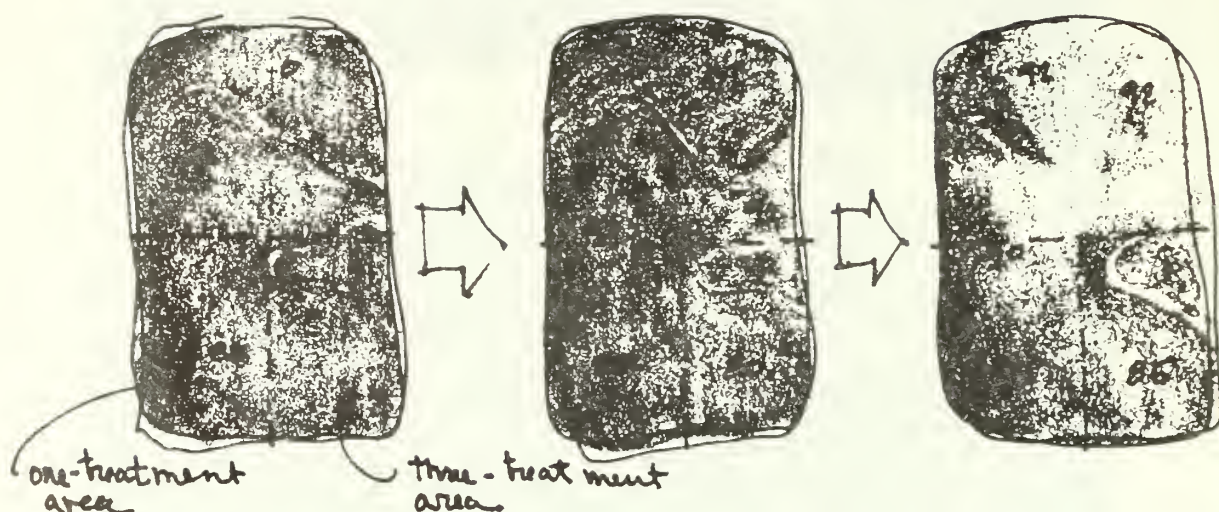
Figure 7: Back side of plaster Sample B showing visible capillary rise and relative surface moisture readings after 1 1/2, 2 1/2, and 4 hours, respectively. The blue areas are those which appear to be wet.

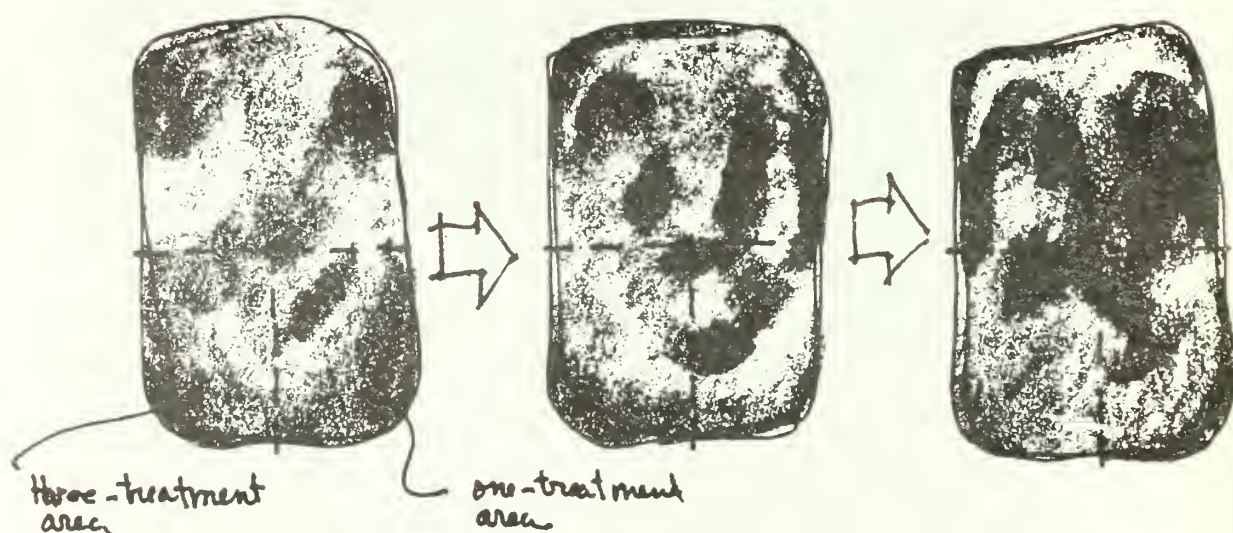
Figure 8: Front side, or finished surface of plaster Sample B showing the formation of efflorescence after 2, 3, and 18 hours respectively. The intensity of the gray areas represents the amount of efflorescence.
